Manhole Inspection Summary

Manhole # S31I__001MH

Insp Date: **12/19/08 10:29 AM**

Location Address: **22 W Lombard St**

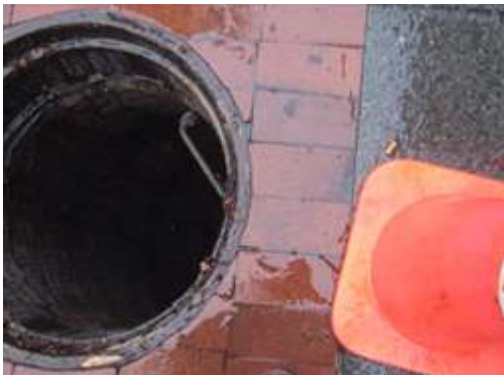
Miscellaneous

standing water

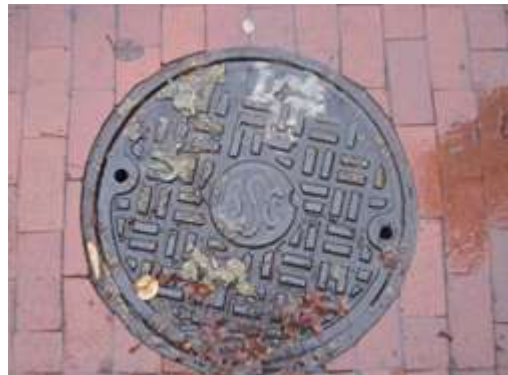
cover pic

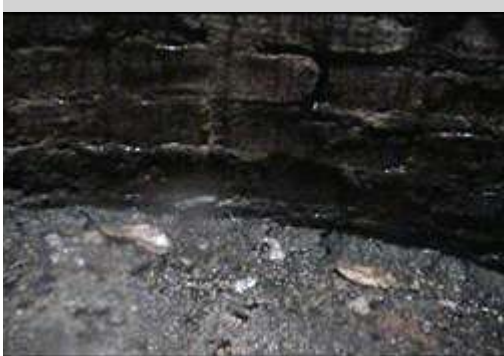
Miscellaneous

debris on bench

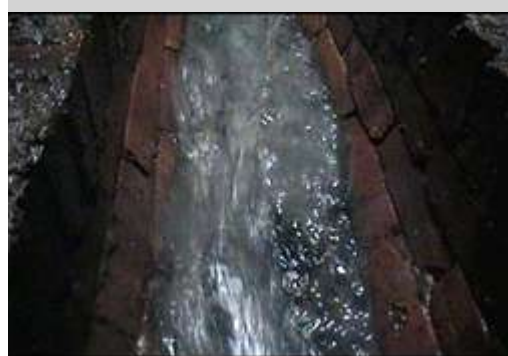
Miscellaneous

sludge in channel

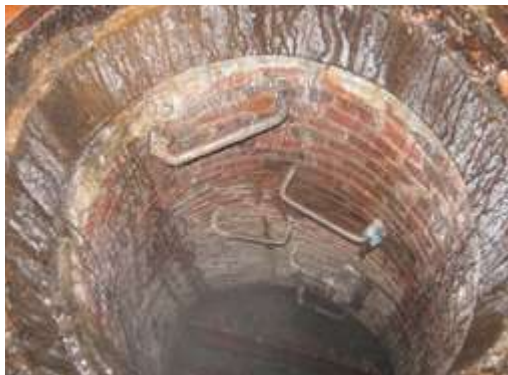
Defect 6

Surcharge ☒ **Evidence Of Surcharge** Depth: **8** (ft.) ☐ Active Surcharge Present

signs of surcharge 8 feet

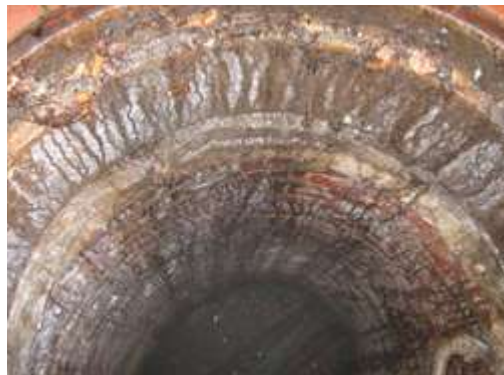
Defect 4

Frame Offset: **1.5** (in.) Condition: ☐ Sound ☐ Cracked ☒ **Leaks**

Infiltration: ☐ None ☒ **Joint** ☐ Cracks ☐ Mortar ☐ Roots ☐ Wall

lid/frame and chimney infiltration, frame offset

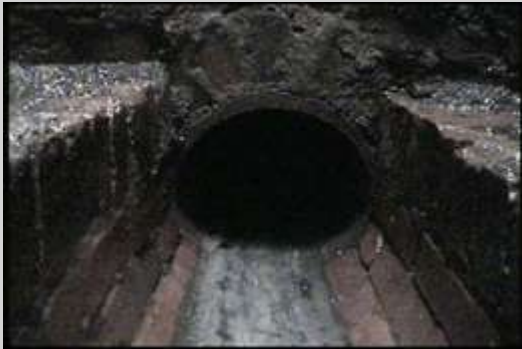
12 O'Clock Outflow

10 in. Circular Gravity Sewer
Pipe Out @ 12 O'Clock

Pipe Height: **10.8** (in.) Rod and Bar (Angled)
Pipe Material: **Clay** ☐ Pipe Lined
Invert Depth: **10.28** (ft.) Flow Characteristics: **Fast**
Deposits: ☐ None ☐ Mud ☒ **Sludge** ☐ Debris ☐ Grease
Silt Depth: **0.5** (in.) Deposits Extent: **Light**
Infiltration: **None** Pipe Seal Cond: **Sound**

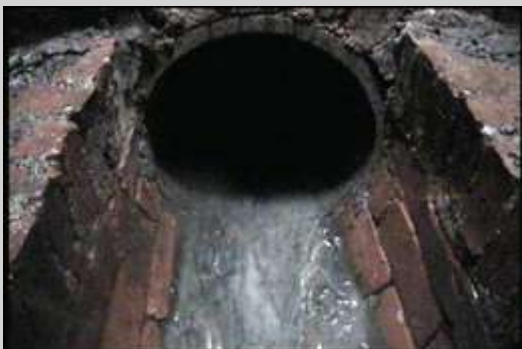
6 O'Clock Inflow

10 in. Circular Gravity Sewer
Pipe In @ 6 O'Clock

Pipe Height: **10.8** (in.) Rod and Bar (Angled)
Pipe Material: **Clay** ☐ Pipe Lined
Invert Depth: **9.49** (ft.) Flow Characteristics: **Fast**
Deposits: ☐ None ☐ Mud ☒ **Sludge** ☐ Debris ☐ Grease
Silt Depth: **1** (in.) Deposits Extent: **Medium**
Infiltration: **None** Pipe Seal Cond: **Sound**
